Report No. CG-D-28-79

STUDY OF TASK PERFORMANCE PROBLEMS IN
REPORTS OF COLLISIONS, RAMMINGS, AND GROUNDINGS
IN HARBORS AND ENTRANCES

FINAL REPORT

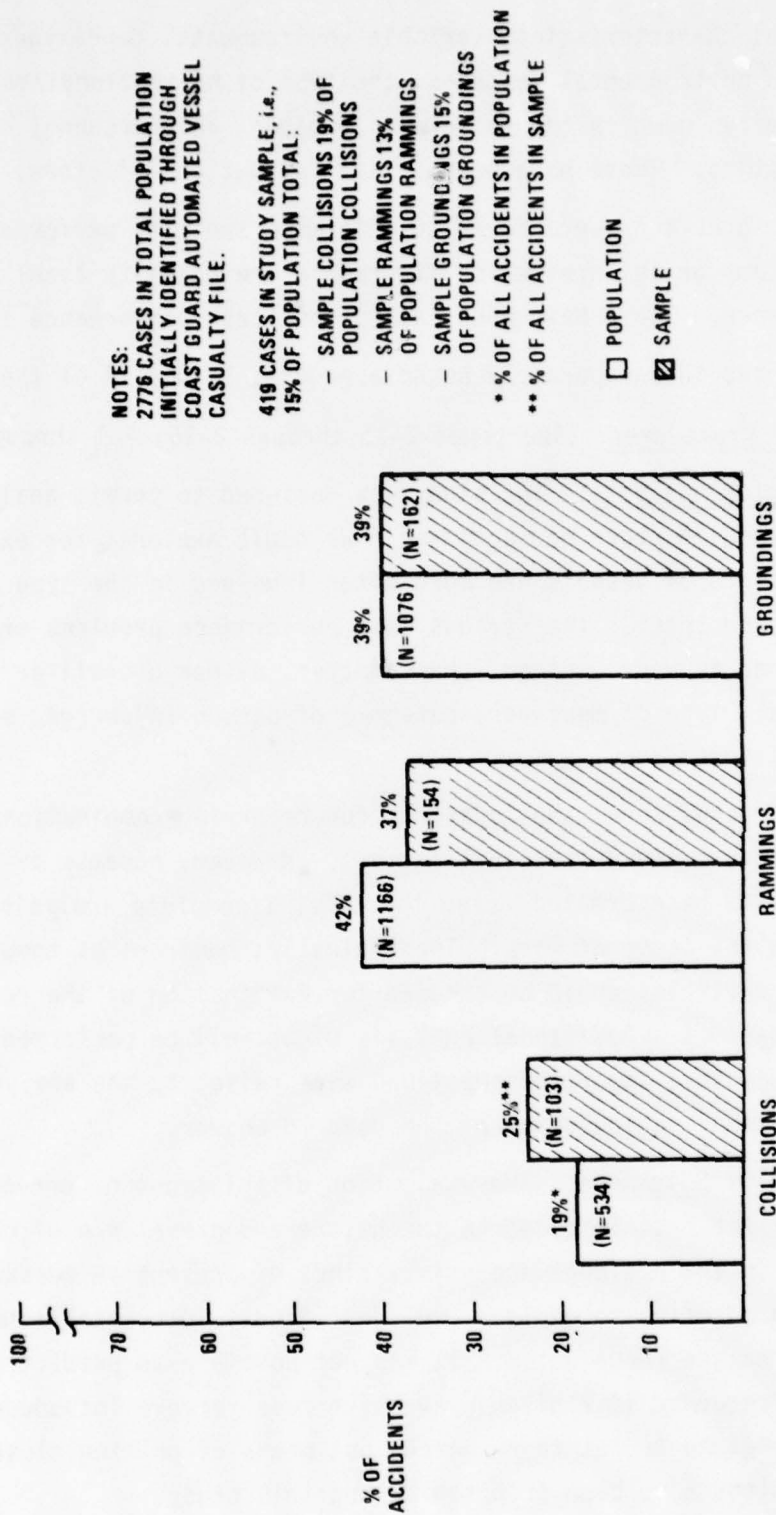
FIGURE 1.1. DISTRIBUTION OF COLLISIONS, RAMMINGS, AND GROUNDINGS:
COMPARISON OF SAMPLE TO POPULATION

Comparisons were made to evaluate the differences between the study sample and population. In general, they appear to be similar, as suggested in Figure 1.1, which shows the distribution of accident types in the initial population versus the final sample. The sample is discussed in more detail in Section II, and additional comparisons are provided which support the view that the study results are generally applicable to the collisions, rammings, and groundings addressed by the study definition.

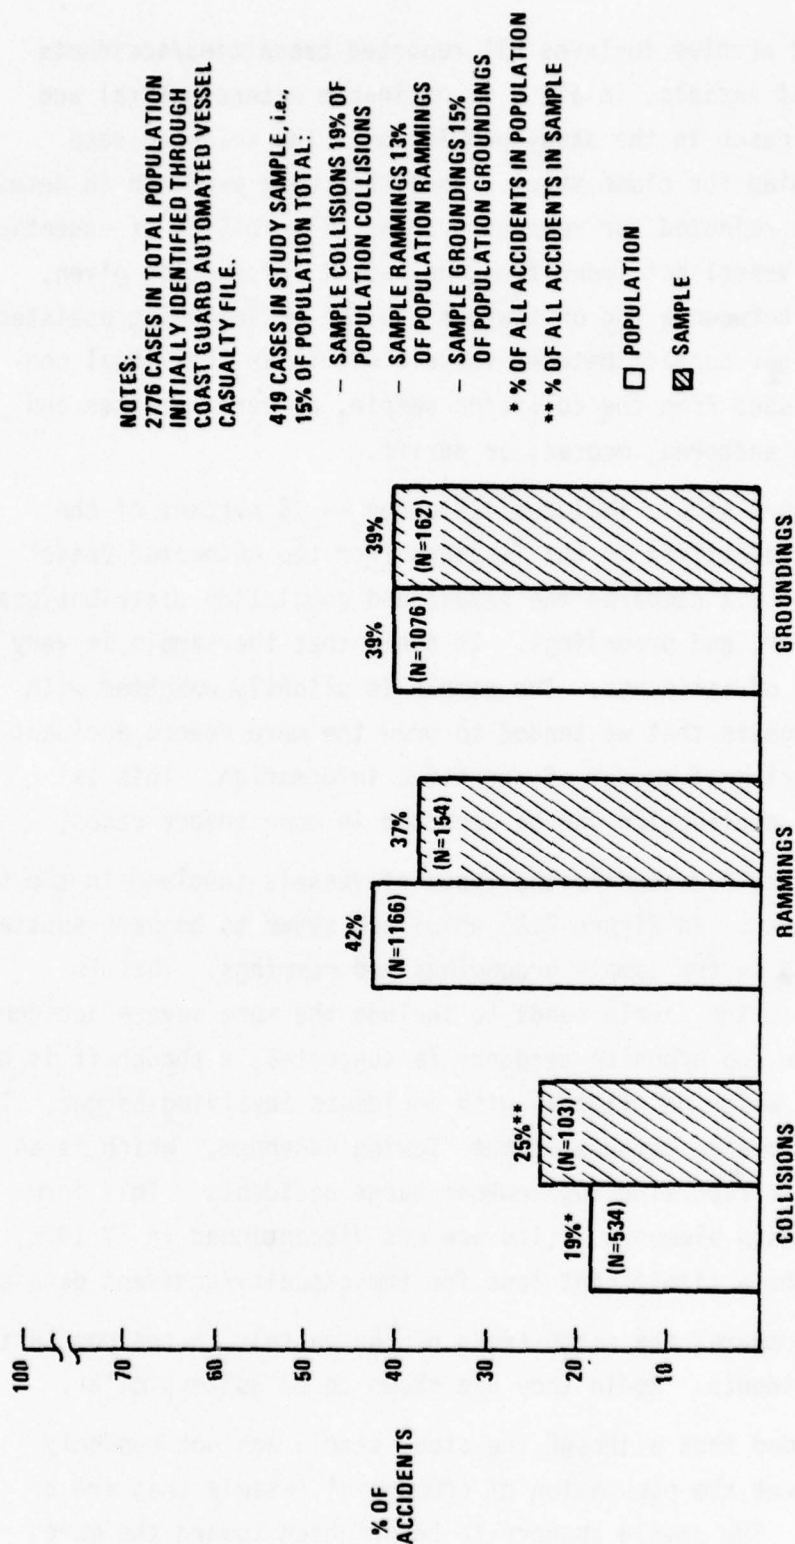
FIGURE 2.1. DISTRIBUTION OF COLLISIONS, RAMMINGS, AND GROUNDINGS:
COMPARISON OF SAMPLE TO POPULATION

The final study sample includes 419 cases -- 15 percent of the population initially identified in the listings from the Automated Vessel Casualty File. Figure 2.1 compares the sample and population distributions of collisions, rammings, and groundings. It shows that the sample is very like the population in mix of accidents. The sample is slightly weighted with collisions. This suggests that we tended to draw the more severe accident cases using the criterion of amount of narrative information. This is reasonable since more explanation can be expected in more severe cases.

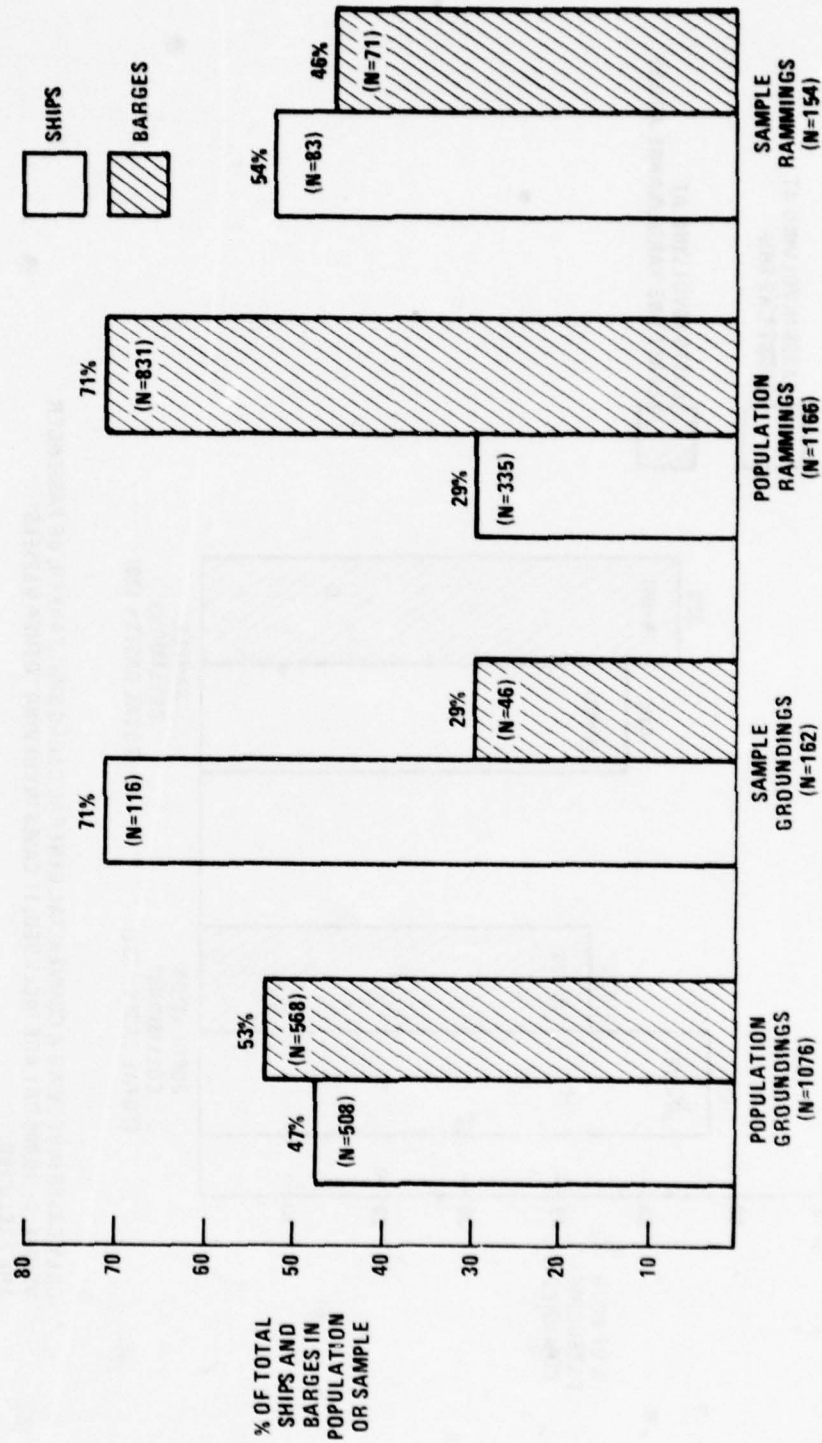
FIGURE 2.2. SHIP AND BARGE INVOLVEMENT IN GROUNDINGS AND RAMMINGS: COMPARISON OF SAMPLE TO POPULATION

Figures 2.2 and 2.3 compare the types of vessels involved in the sample and population accidents. In Figure 2.2, ships are shown to be very substantially overrepresented in the sample groundings and rammings. That is another indication that the sample tends to include the more severe accidents. In Figure 2.3, however, an opposite tendency is suggested, although it is not marked; the sample is weighted slightly with accidents involving barges. This is believed to have happened because of the "Towing Addendum," which is an additional form used in reporting tug/towboat-barge accidents. This form includes very useful data elements. (Its use was discontinued in FY 1976, which is believed to be a significant loss for the casualty/accident data base.)

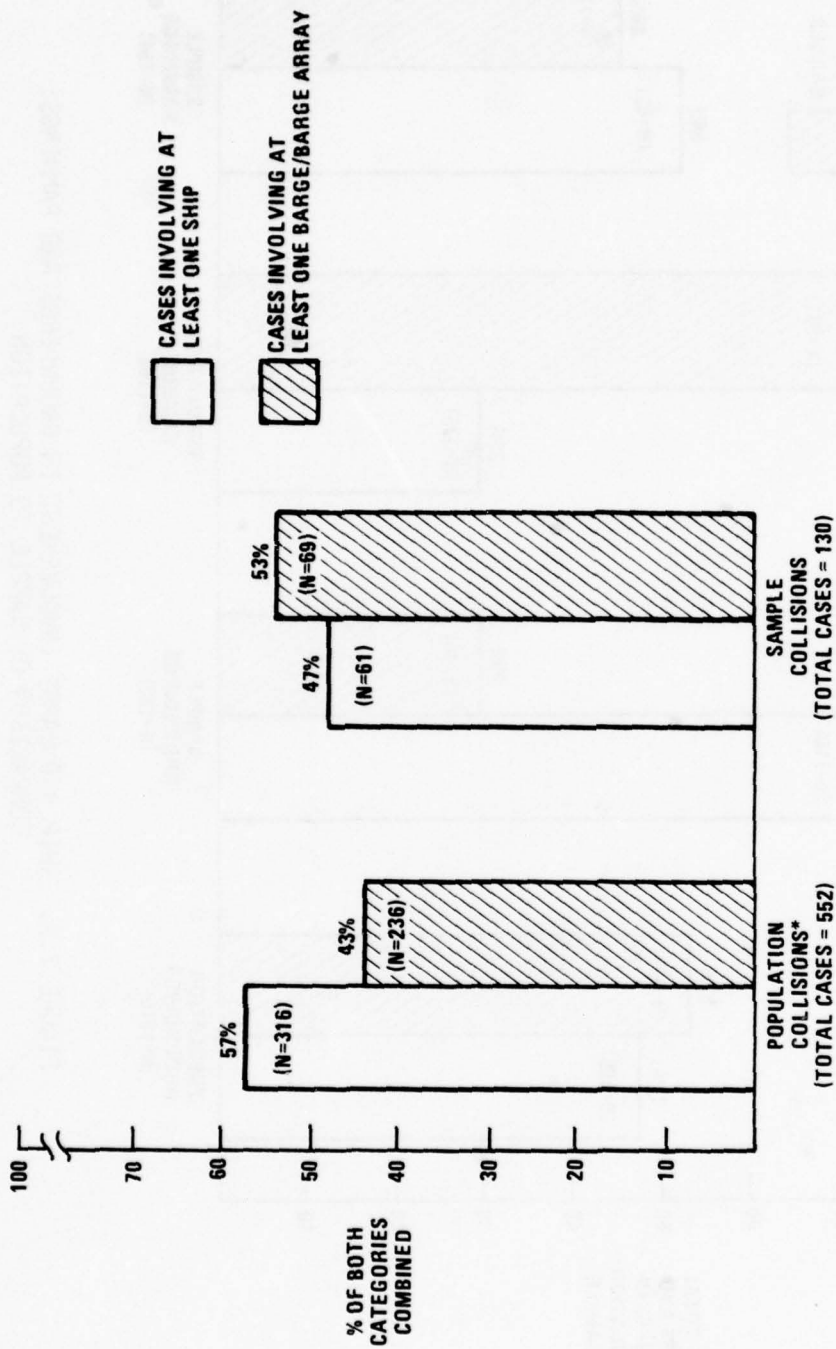
FIGURE 2.3. SHIP AND BARGE INVOLVEMENT IN COLLISIONS:
COMPARISON OF SAMPLE TO POPULATION

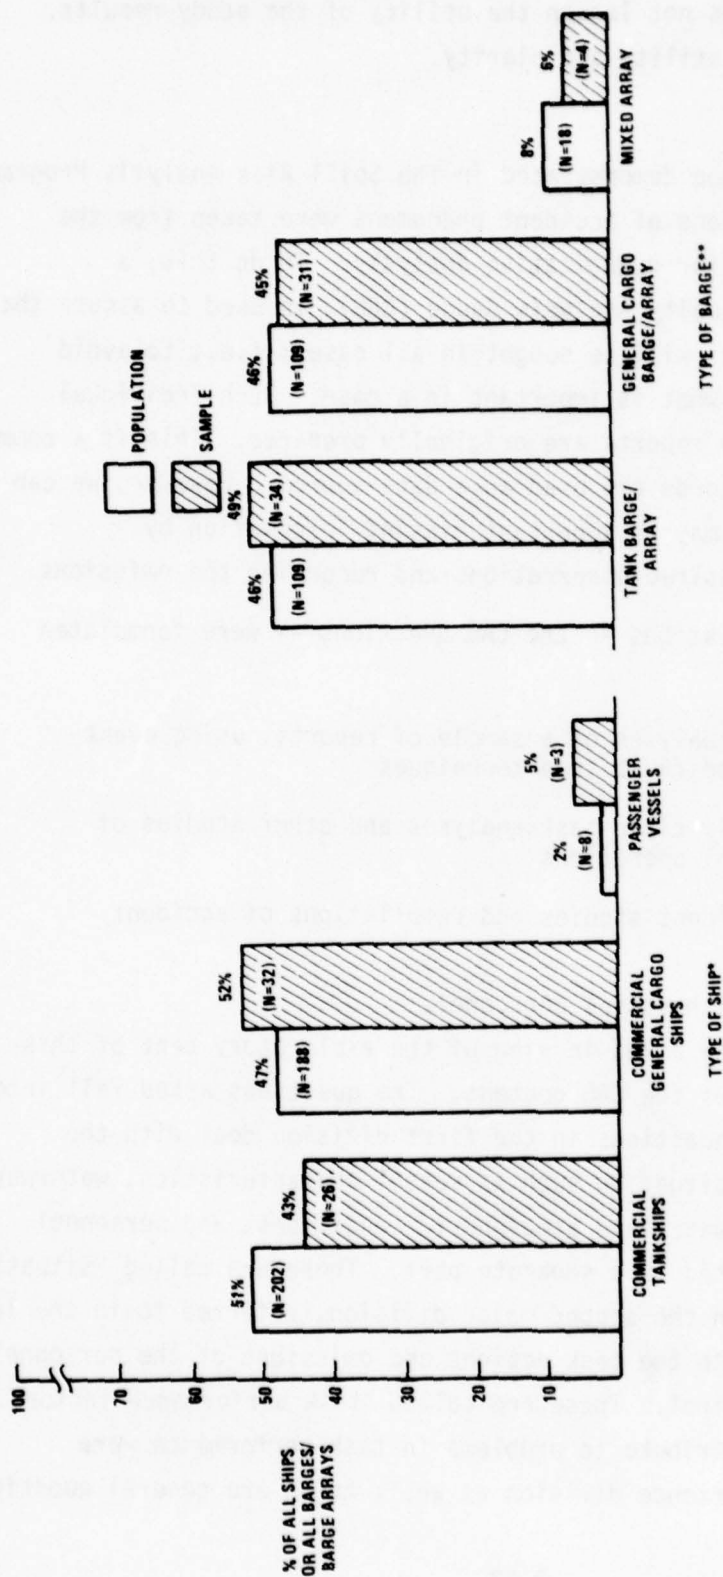
* POPULATION TOTAL = 398; EXCLUDES 11 "OTHER" VESSEL >10,000 GRT IDENTIFIED IN POPULATION.

SAMPLE TOTAL = 61.

FIGURE 2.4. RELATIVE PROPORTIONS OF CARGO TYPES FOR SHIPS AND BARGES: COMPARISON OF SAMPLE TO POPULATION

Figure 2.4 compares the cargo types of the vessels in the population versus the sample accidents. Again they are shown to be quite similar.

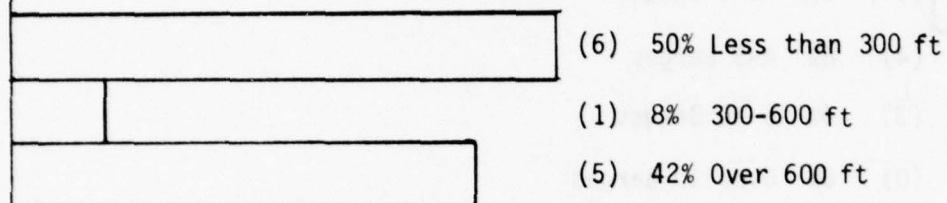
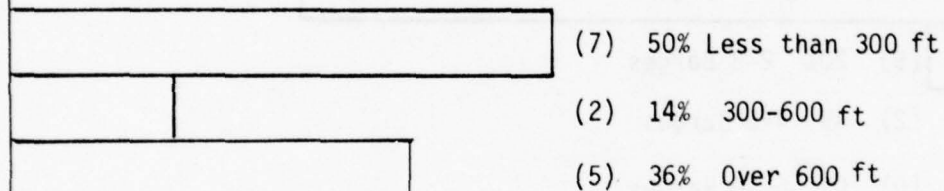
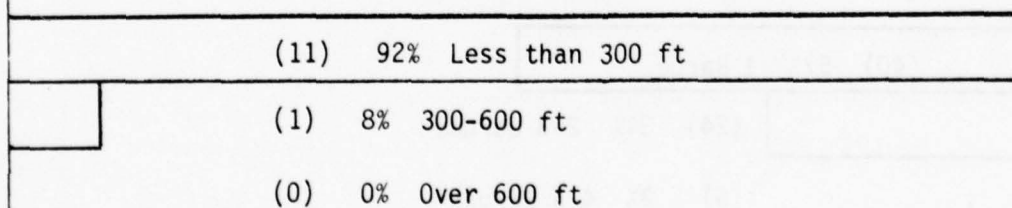
VESSEL DESCRIPTION - CHART 3.14

BARGES: HAWSER LENGTH (COLLISIONS)

BARGES: HAWSER LENGTH (GROUNDINGS)

BARGES: HAWSER LENGTH (RAMMINGS)

NOTE: Percentages based on number cases in which hawser used.

As shown in Charts 3.12 - 3.17, the tug/towboat-barge configurations in the accidents studies typically consisted of a single towing vessel pushing a single, loaded barge. These characteristics hold in a majority of the cases of all three accident types. However, in the rammings cases, more than one towing vessel and more than one barge were involved, notably more often than in the collision and grounding cases.

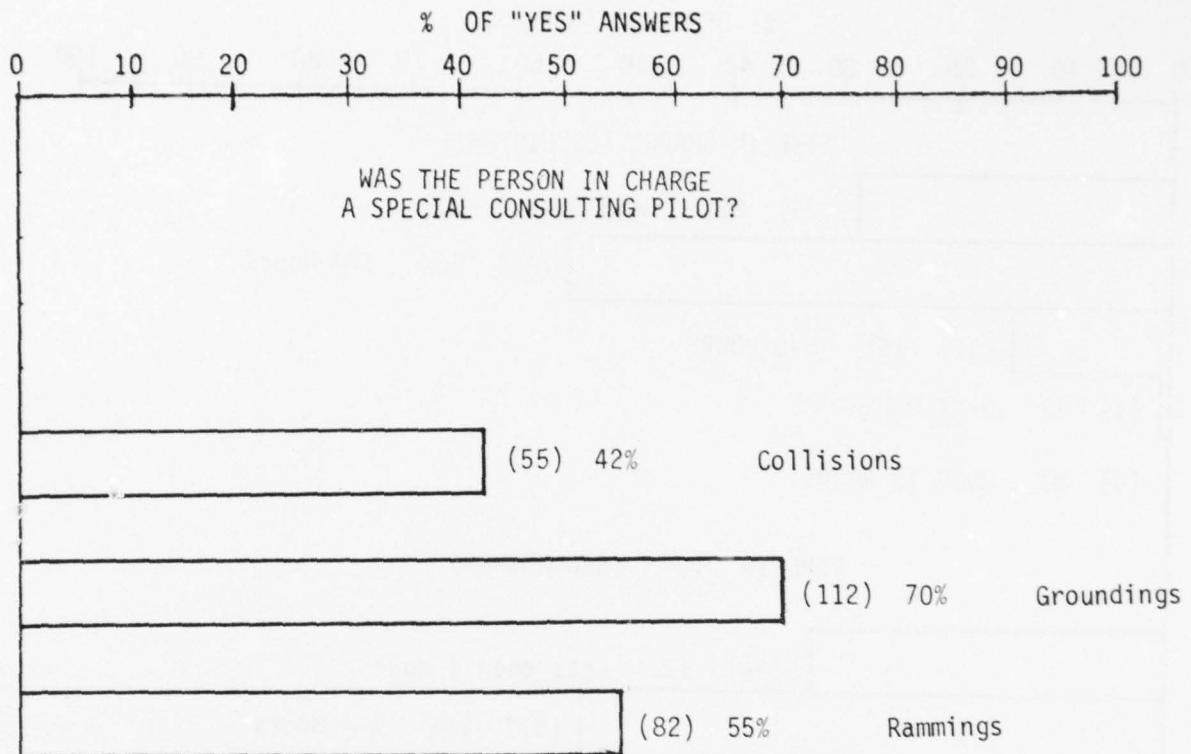
PERSONNEL INFORMATION - CHART 3.26

NOTE: This question is vessel-related because there is a person in charge for every vessel of interest.
The base numbers are:

There are only two questions analyzed in this section. The first is the category of person in charge at the time of the accident; the second is the length of time the person in charge had been on watch at the time of the accident. Questions were asked on several other personnel topics (see the Casualty Analysis Gauges in the appendix), but only the two discussed here were answered in at least 60 percent of the cases.

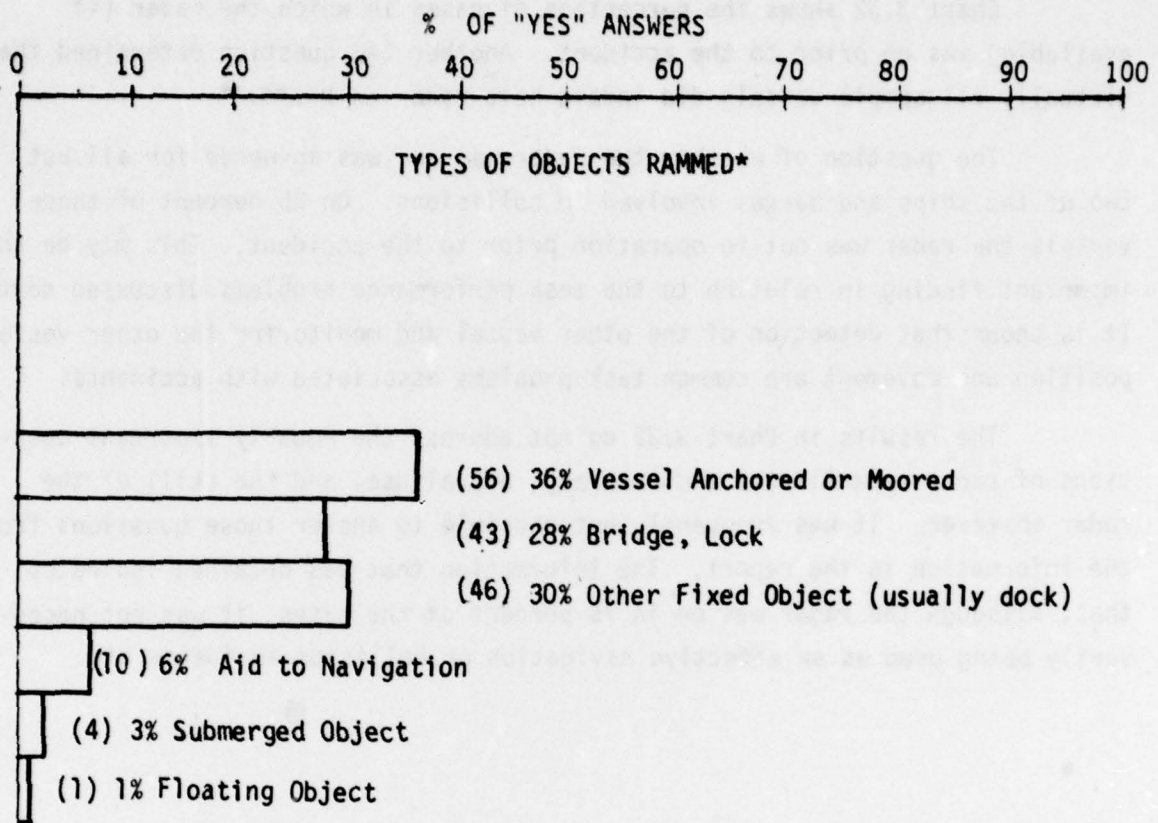
OTHER QUESTIONS - Chart 3.28

Note: Some of these figures are approximate and are based on assumptions made in the preceding discussion section.

Total number of struck objects exceeds number of ramming cases (154) cases because in a few instances more than one object was struck. Percentages are based on the number of cases.

Charts 3.28-3.32 present a number of questions on natural and man-made hazards, on the use of radar, and on the types of meetings that resulted in collisions. The most significant findings are that

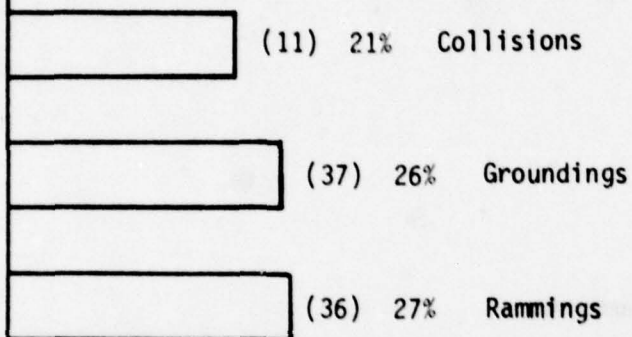
VESSEL WAS IN A SHARP TURN (>20 deg)
AT THE TIME OF THE ACCIDENT

Percentages are based on the total number of cases in which a yes/no determination could be made. The base numbers are:

Collisions	53
Groundings	141
Rammings	132

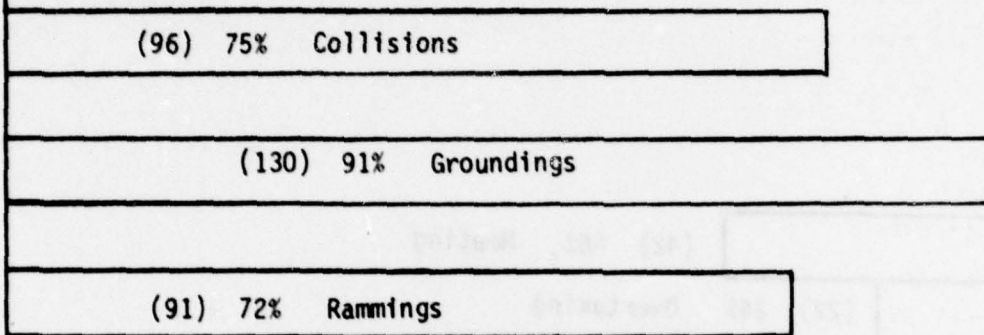
OTHER QUESTIONS - CHART 3.32

IF VESSEL WAS EQUIPPED WITH RADAR,
WAS IT ON PRIOR TO ACCIDENT?

Percentages are based on the number of cases in which
(a) the vessel had radar and (b) it was possible to
determine whether radar was on. The base numbers are:

Collisions	128
Groundings	143
Ramming	127

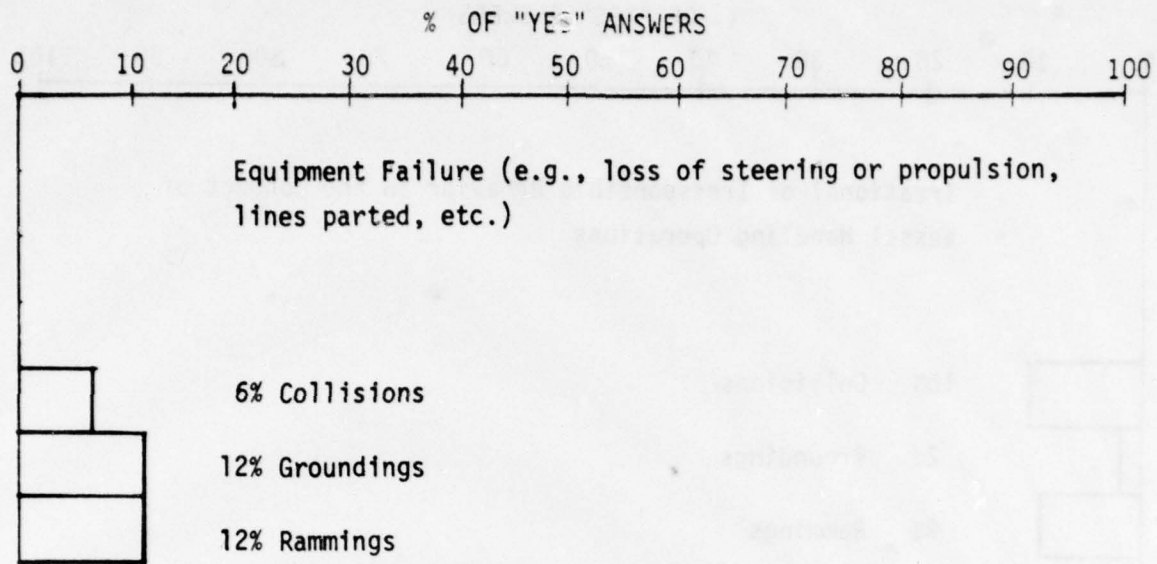
CASUALTY PRECIPITATING FACTORS - CHART 3.33

These percentages reflect the answers to question VI. 17 in the R/G-CAG and questions XII. 14 and XII. 15 in the C-CAG.

Collisions	2 PV only + 4 OV only = 6/103
Groundings	20/162 .
Ramblings	18/154

The analysis distinguished three situations in which effective vessel control cannot reasonably be expected: (a) failure of the means of control including propulsion or steering failure, barge breakaway and the like; (b) irrational/irresponsible behavior on the part of vessel handling personnel; (c) "cataclysmic event," such as hurricane, death of helmsman, etc. These kinds of situations were found to be relatively rare:

- 10 percent of all accidents studied involved (often originated with) equipment failure as defined above.
- 6 percent of all accidents studied involved irrational or irresponsible behavior on the part of vessel handling personnel. Irresponsible behavior was cited most often in collision cases (10 percent).
- Only one of the 419 accidents was considered to have involved a cataclysmic event (a hurricane).

Equipment Failure. Equipment failure was defined to exclude problems with navigational equipment or with equipment not onboard ship, such as a drawbridge or malfunctioning light. It does include other onboard problems such as loss of steering, loss of propulsion, parted lines, etc. As shown in Chart 3.33, equipment failure was found to be a factor in 12 percent of both ramming and groundings. The factor is predictably less common in collisions (6 percent) because only in tight situations with other vessels close at hand would a sudden failure result in a collision.

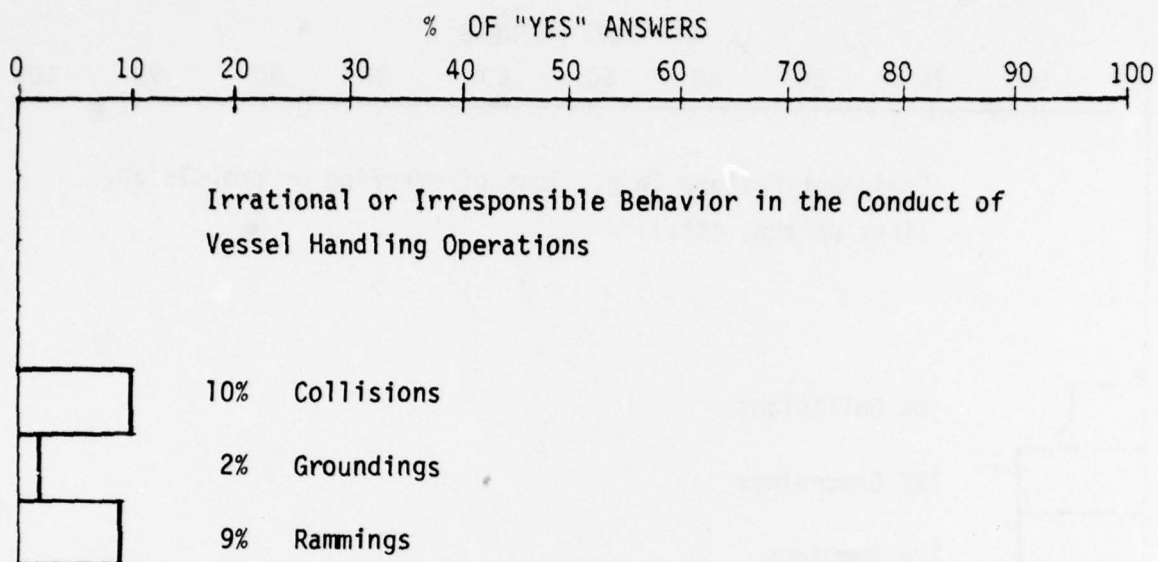
CASUALTY PRECIPITATING FACTORS - CHART 3.34

These percentages reflect the answers to question VI.19 in the R/G-CAG and XII.12 and XII.13 in the C-CAG

Collisions	1 PV only + 9 OV only = 10/103
Groundings	3/162
Rammings	14/154

Irrational or Irresponsible Behavior. This category most commonly included the person in charge being asleep or drunk, leaving a completely inexperienced person alone at the helm, or otherwise clearly abdicating his responsibilities for vessel control. These exceptional behaviors appeared as causal factors in 10 percent of the collisions, 9 percent of the ramming, and only 2 percent of the groundings (Chart 3.34). It should be noted that in 9 of the 10 collision cases attributed to irresponsible behavior, it occurred on the "other" vessel, where the other vessel was not a large commercial ship or barge configuration.

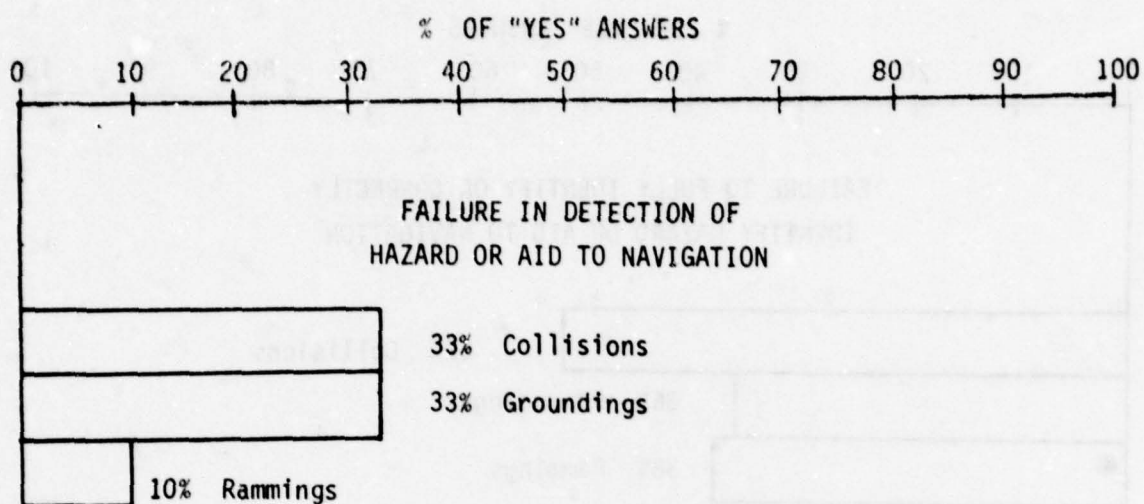
CASUALTY PRECIPITATING FACTOR - CHART 3.35

The percentages reflect answers to question VI. 11 in the R/G-CAG and questions XII. 37 and XII. 38 in the C-CAG.

Collisions	8 PV only + 6 OV only + 15 both = 29/88
Groundings	53/162
Rammings	15/154

This example shows that there were 8 collisions in which only the primary vessel failed to detect a hazard/aid, that there were 6 collisions in which only the other vessel failed to detect a hazard/aid, and that there were 15 collisions in which both vessels failed to detect a hazard/aid. The total on the far right states that 29 out of the 88 collision cases looked at involved a failure to detect a hazard or aid on the part of one or both vessels.

Failure to Detect Hazard or Aid to Navigation. It was found that about one third of all collisions and groundings studied involved a failure to detect a particular hazard or aid. In the collision cases, the hazard/aid was most often the other vessel; in the grounding cases, it was most often the area of low water or a navigational landmark that was completely missed.

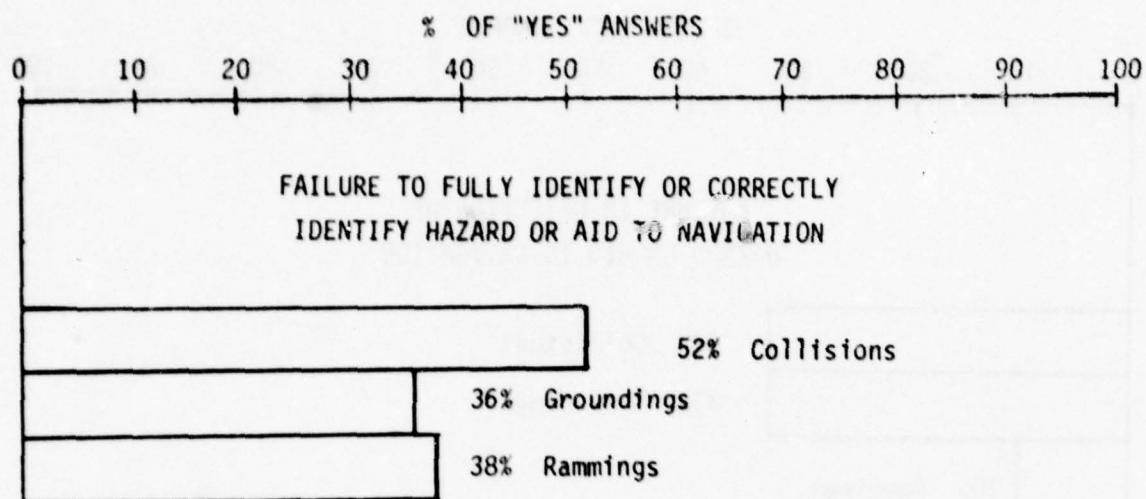
CASUALTY PRECIPITATING FACTORS - CHART 3.36

The percentages reflect the answers to question VI. 12 in the R/G-CAG and questions XII. 48 and XII. 49 in the C-CAG.

Collisions	12 PV only + 9 OV only + 25 both = 46/88
Groundings	59/162
Rammings	58/154

Fully identifying or correctly identifying a hazard or aid is a completion of the information gathering process begun when the hazard or aid was first detected. This question was geared toward gauging how often the information that an operator is receiving about a previously detected hazard/aid is inadequate. Some common examples of failures as coded are given below:

Over half of the collisions studied involved some type of breakdown of these sorts. The most common failure to identify as far as collisions are concerned is inadequate monitoring. This problem differs from other failures by the fact that in most cases where failure to monitor was noted, important information (where is the other vessel headed, at what speed, etc.) was available but not being actively gathered in any systematic fashion. Most other failures to identify originated in an inability to collect the data.

Over a third of the ramblings and groundings studied were also associated with the problems of hazard/aid identification. A majority of these were related to an inability to fully understand the magnitude of environmental factors (wind, current) and their effects on the vessel.

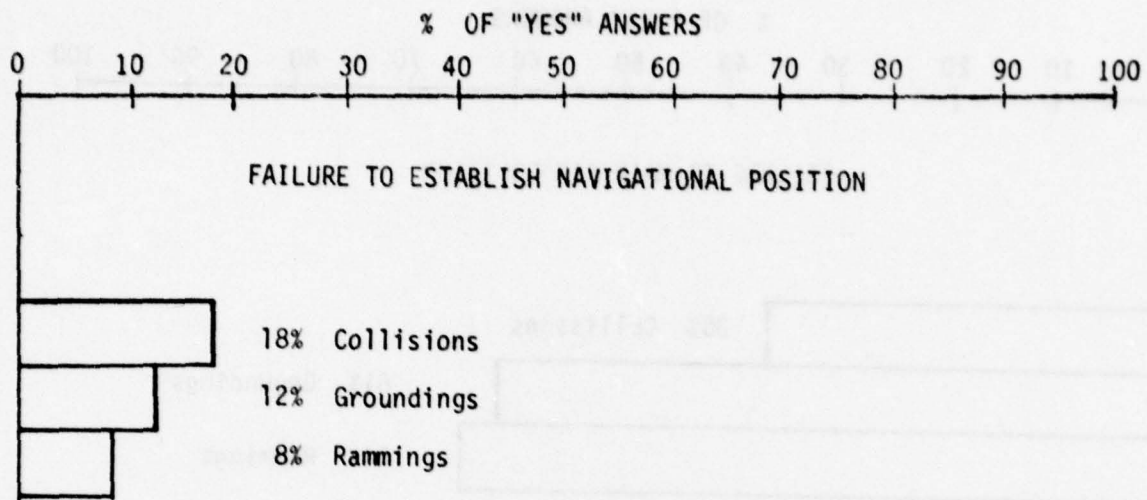
CASUALTY PRECIPITATING FACTORS - CHART 3.37

The percentages reflect answers to question VI. 13 in the R/G-CAG and questions XII. 50 and XII. 51 in the C-CAG.

Collisions 3 PV only + 8 OV only + 5 both = 16/88
 Groundings 20/162
 Ramming 13/154

Failure to Establish Navigational Position. Failure to establish navigational position was found to be a precipitating factor in 12 percent of all the accidents studied. To be considered a precipitating factor, it had to be considered significant that the operator was not aware of his vessel's position and/or orientation relative to some hazard or that the person in charge felt certain as to his whereabouts but was incorrect. This was found most often in collisions that occurred during periods of poor visibility, when a vessel would gradually move across a channel into the way of an oncoming vessel. Cases in which the PIC knowingly directed the vessel to a hazardous or inappropriate location were coded as failures in evaluation.

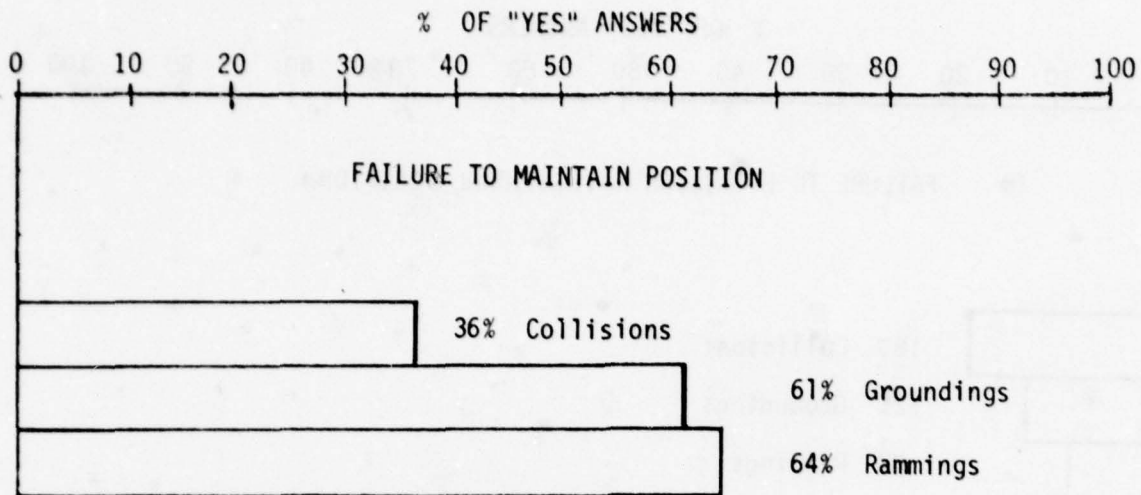
CASUALTY PRECIPITATING FACTORS - CHART 3.38

These percentages reflect answers to questions VI. 15 in the R/G-CAG and questions XII. 73 and XII. 74 in the C-CAG.

Collisions	16 PV only + 12 OV only + 4 both = 32/88
Groundings	99/162
Ramming	98/154

Failure to Maintain Position. This is the most common of all problems cited in the causal factors section. Maintaining position was found to be a problem in over 60 percent of both ramming and groundings cases and in 36 percent of the collision cases. The criteria for coding failure to maintain position is related to a vessel's inability to realize an intended path. These "intended paths" were not irrational hopes such as wanting a 10,000 GRT vessel doing 5 knots to stop in 100 yards, but were considered to be more reasonable expectations of what the vessel could do. Some examples are: a PIC on a barge intending to position his vessel close to a bridge support in order to get in line for an upcoming turn finds suction (or wind or current) forces the barge to scrape the bridge support; a barge is pushed aground by high seas; a ship in a turn reacts surprisingly slowly, crosses the channel and strikes an oncoming vessel.

Current, wind, and suction effects near structures and channel banks predominate as contributing or underlying factors in cases of failure to maintain position leading to the groundings and ramming. In the collision cases, failure to maintain position is less often attributed to the effects of environmental forces.

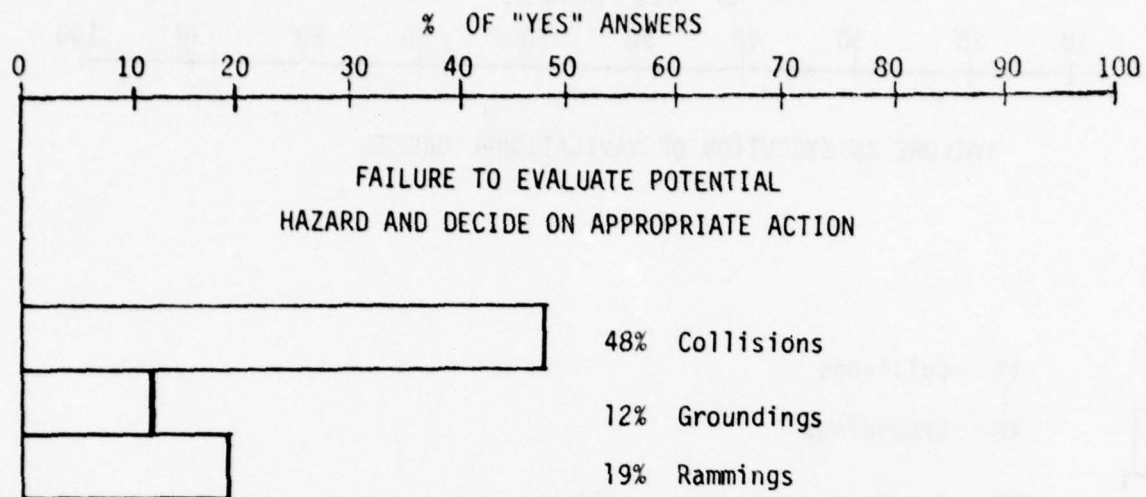
CASUALTY PRECIPITATING FACTORS - CHART 3.39

These percentages reflect answers to question VI. 15 in the R/G-CAG and questions XII. 45 and XII. 46 in the C-CAG.

Collisions 11 PV only + 16 OV only + 15 both = 42/88
 Groundings 19/162
 Rammings 30/154

Failure to Evaluate Potential Hazard and Decide on Appropriate Action. This question attempted to separate problems in evaluating information from problems related to the amount and quality of the information input. Failure to evaluate could be demonstrated by either failure to act or action inappropriate for the situation. This question would be scored "yes" only if it could

be reasonably inferred that all relevant information was available to the person in charge. This type of breakdown arose most frequently in collision cases (48 percent), where an operator was often found to recognize another vessel as a potential threat but took no action to assure a safe, unambiguous passing.

Failure in evaluating hazards was cited as a precipitating factor far less often in groundings (12 percent) and in rammings (19 percent).

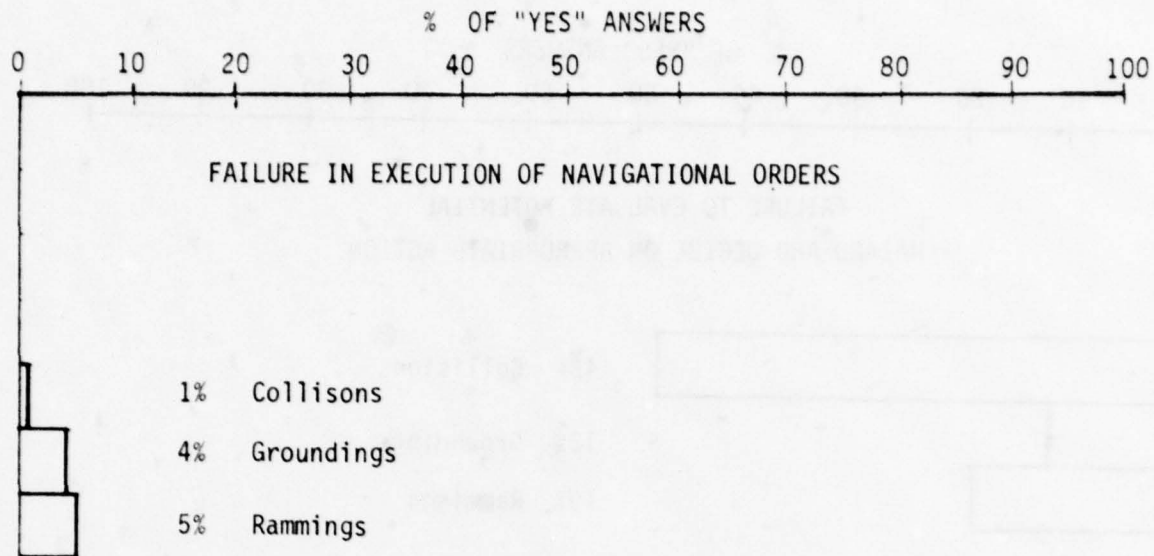
CASUALTY PRECIPITATING FACTORS - CHART 3.40

These percentages reflect the answers to question VI. 16 in the R/G-CAG and questions XII. 33 and XII. 34 in the C-CAG.

Collisions	1 OV = 1/88
Groundings	6/162
Rammings	8/154

Failures in Execution of Navigational Orders. This question concerns inability, confusion, or unwillingness in executing rudder or engine orders as given by the person in charge. The most common of these was a temporary confusion on the part of a crew member (most often the helmsman). This type of problem was found to be relatively uncommon, as shown in Chart 3.40. The greater frequency of failure in the execution of navigational orders in rammings and groundings as compared to collisions might reflect greater maneuvering limitations in the areas where ramming and groundings tend to occur.

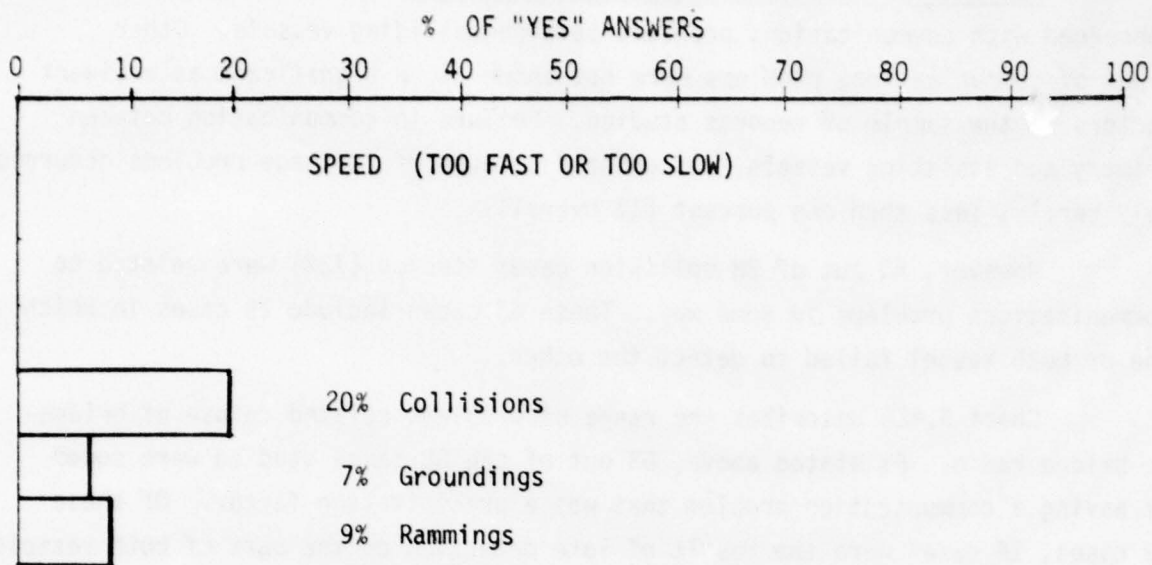
CASUALTY PRECIPITATING FACTORS - CHART 3.41

These percentages reflect answers to question VI. 50 in the R/G-CAG and XIII. 19 in the C-CAG.

Collisions	18/89
Groundings	11/162
Rammings	14/154

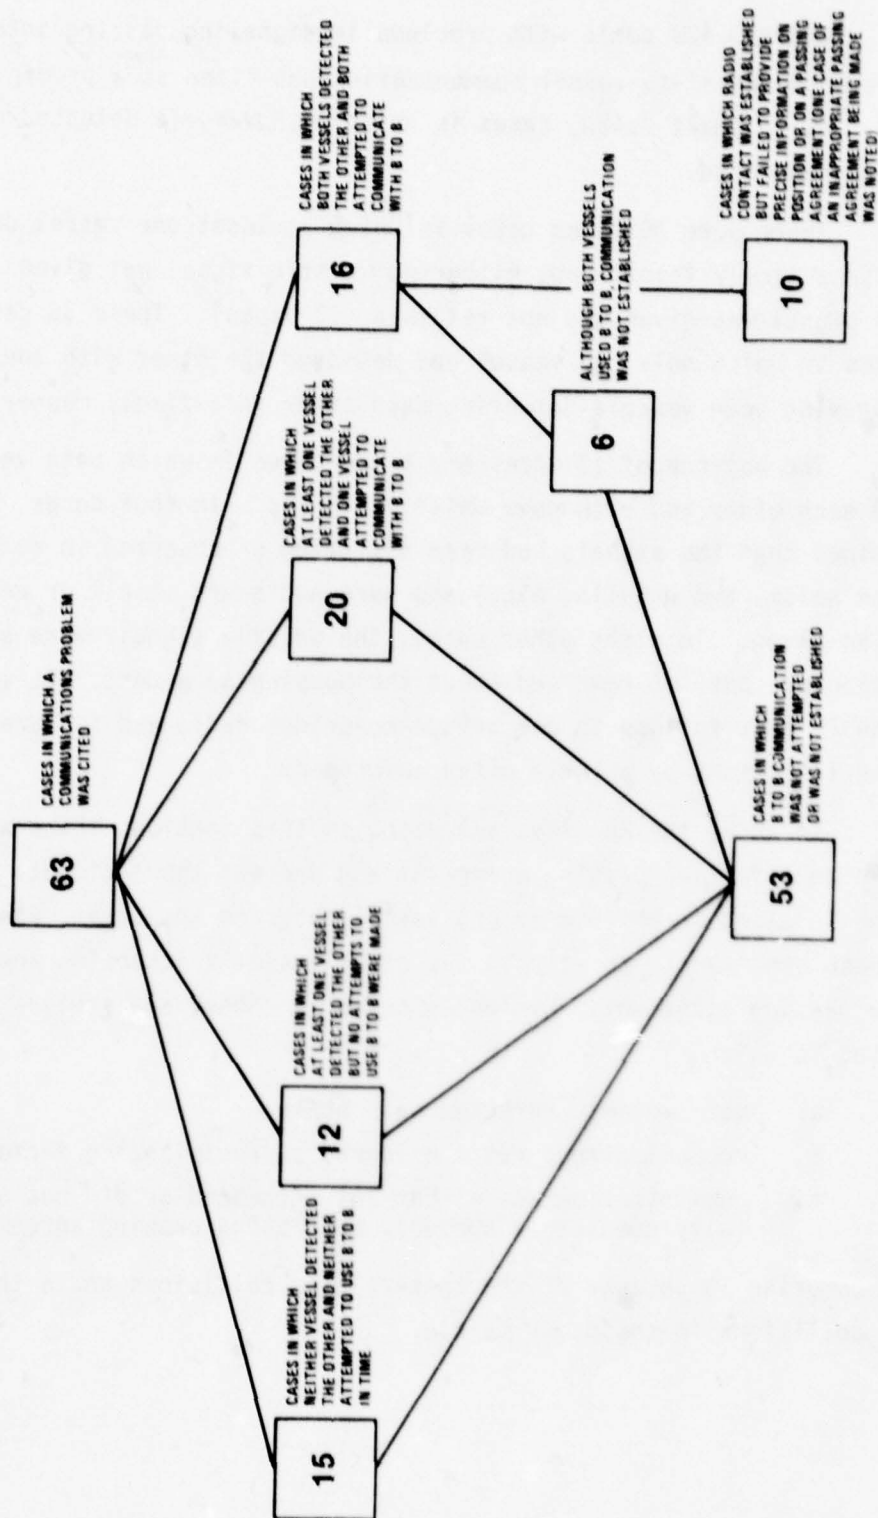
PROBLEM ARISING IN THE USE OF BRIDGE TO BRIDGE RADIO

This chart demonstrates the use of bridge to bridge radio (b to b) in those 63 collision cases in which a communications problem was sighted as a precipitating factor.

However, 63 out of 88 collision cases studied (72%) were related to communications problems in some way. These 63 cases include 29 cases in which one or both vessel failed to detect the other.

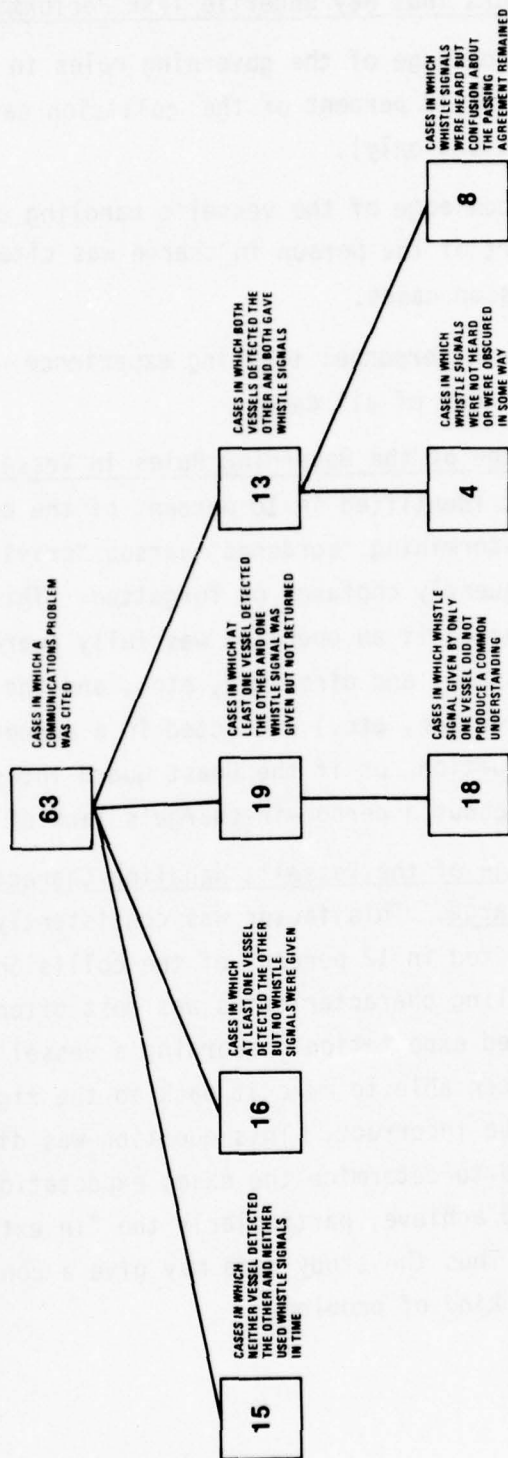
PROBLEMS ARISING IN THE USE OF WHISTLE SIGNALS

This chart demonstrates the use of whistle signals in those 63 collision cases in which a communications problem was sighted as a precipitating factor.

NOTE: DISCREPANCIES IN THIS CHART ARE THE RESULT OF ERRORS IN CODING THE COLLISION CASES. THE SECTION ON COMMUNICATIONS PROBLEMS (XII 60, 70, XII 72) USED A BRANCHING SCHEME WHICH WAS MISINTERPRETED ON AT LEAST TWO OCCASIONS.

Chart 3.42B deals with problems in signaling passing intentions by whistle when vessel-to-vessel communication was cited as a precipitating factor. As in Chart 3.42A, cases in which both vessels detected each other late are separated.

There were 35 other cases in which at least one vessel detected the other in a timely fashion but either no whistle signal was given (16 cases) or one signal was given and not returned (19 cases). These 35 cases contain 14 cases in which only one vessel had detected the other with the remainder (21) showing both vessels detecting each other in a timely manner.

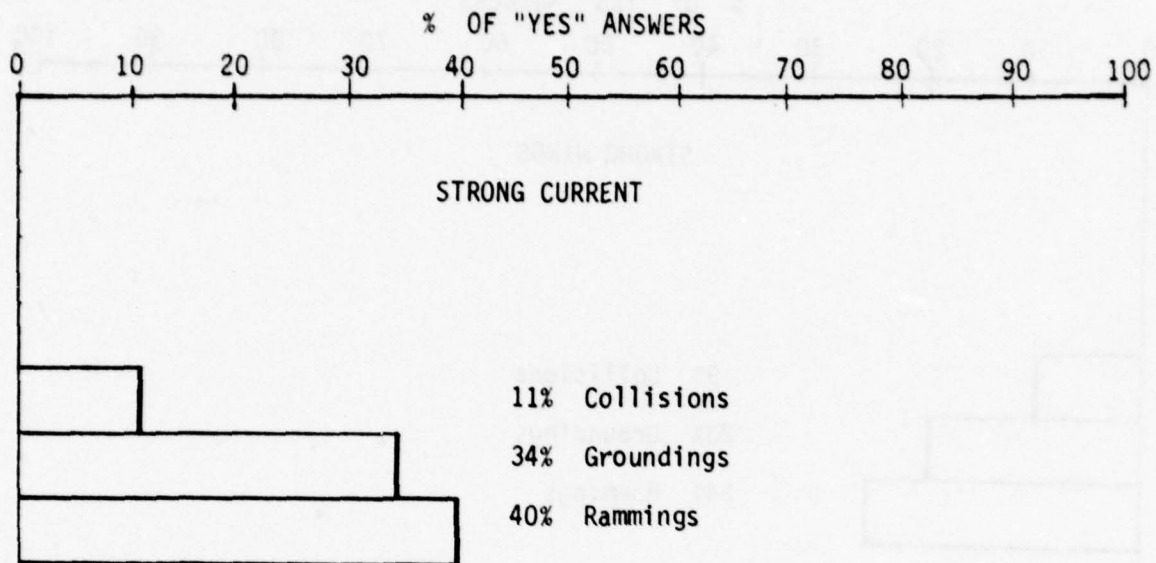
CASUALTY PRECIPITATING FACTORS - CHART 3.43

These percentages reflect the answers to question VI. 20 in the R/G-CAG and questions XII. 18 and XII. 19 in the C-CAG.

Collisions	6 PV + 4 OV = 10/88
Groundings	55/162
Rammings	62/154

Strong Tidal Conditions. This question was defined to exclude tidal currents in order to emphasize high waves and rough seas. The effects of tidal currents were scored as "strong current" when appropriate.

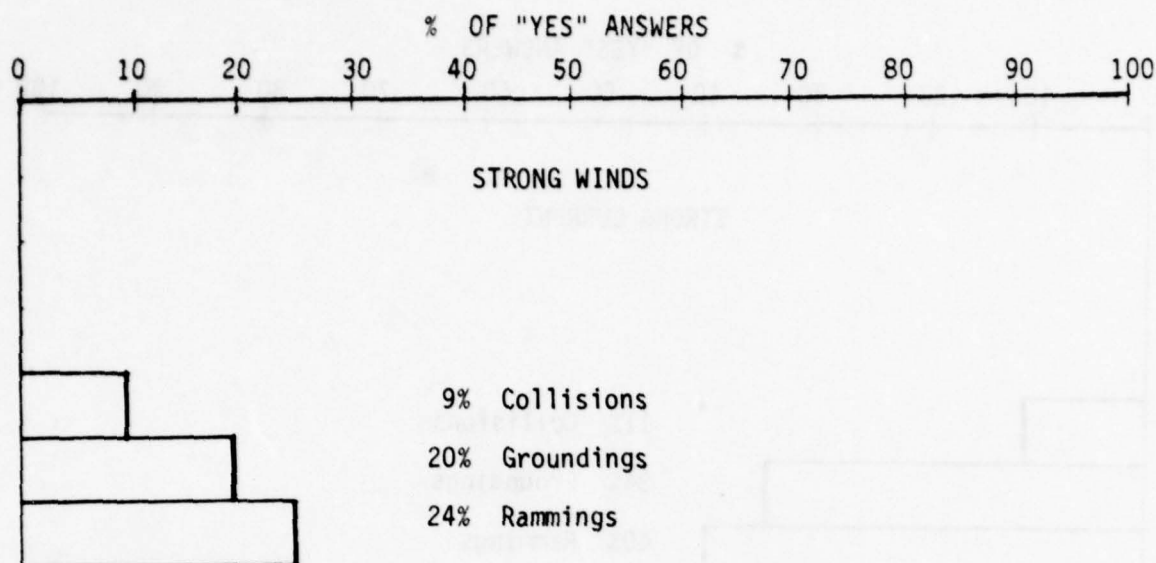
CASUALTY PRECIPITATING FACTORS - CHART 3.44

These percentages reflect the answers to question VI. 21 in the R/G-CAG and questions XII. 20 and XII. 21 in the C-CAG.

Collisions	5 PV + 2 OV + 1 both = 8/88
Groundings	33/162
Rammings	37/154
